AUTOSONIC™

Gas cylinders: flaw collection

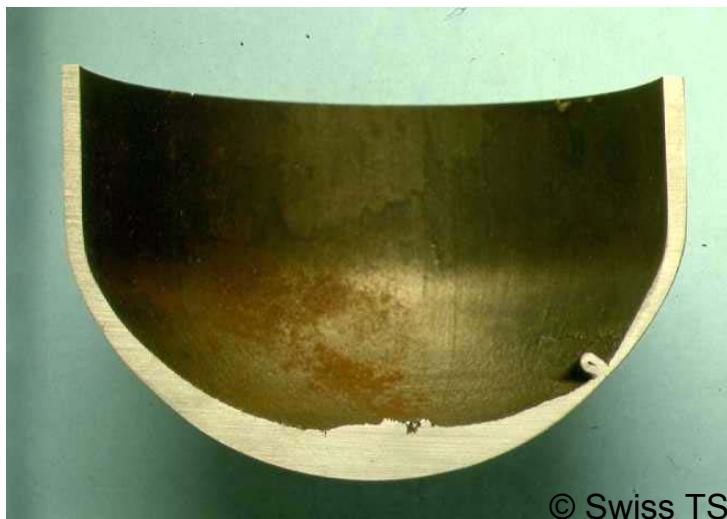
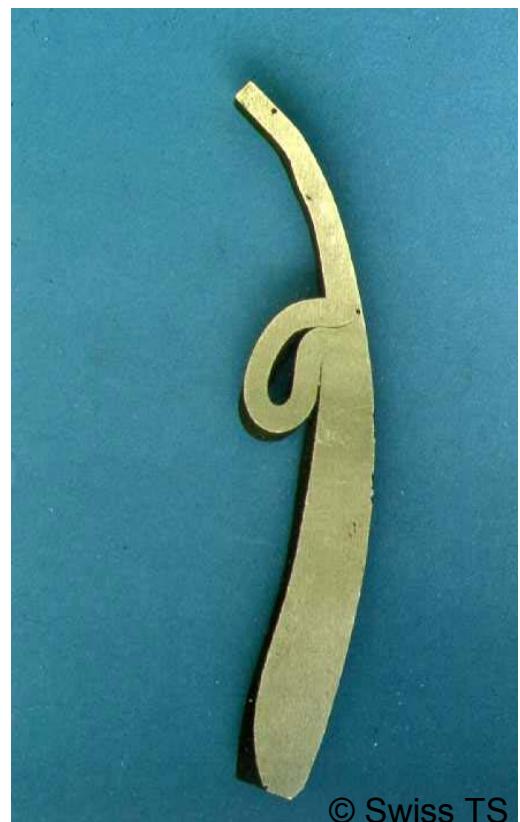
Picture 1 und 2: Manufacturer defects

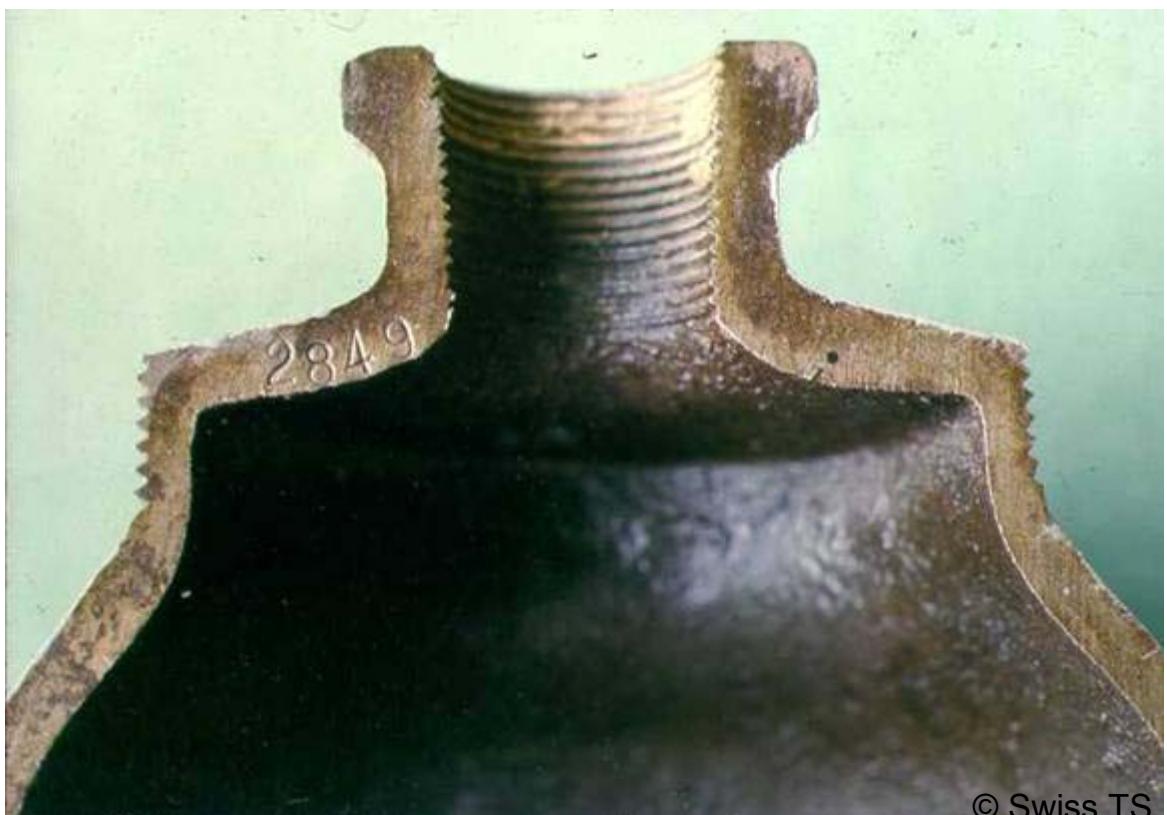
Picture 3: design fault

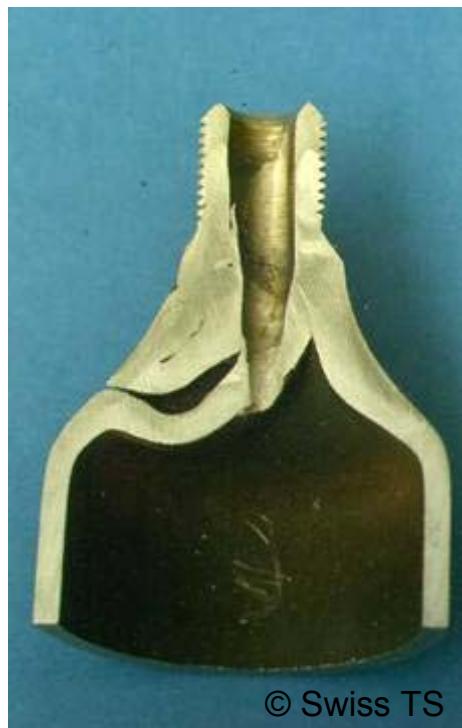
Picture 4: Manufacturer defect

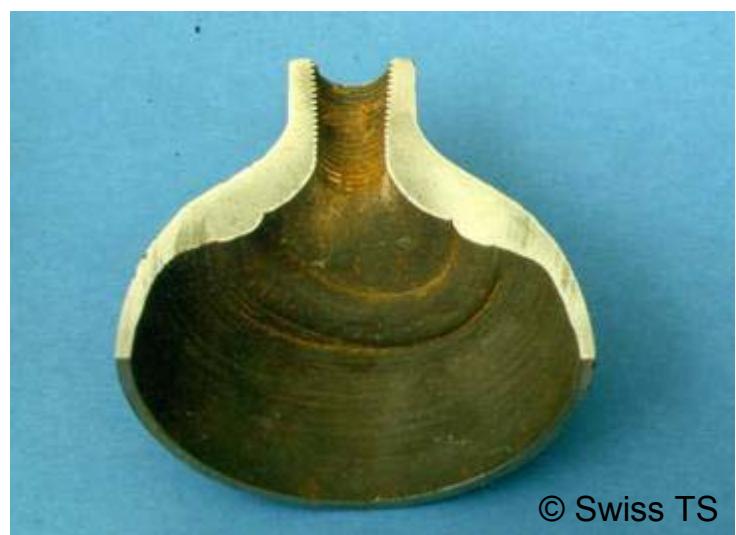
Picture 5: Manufacturer defect

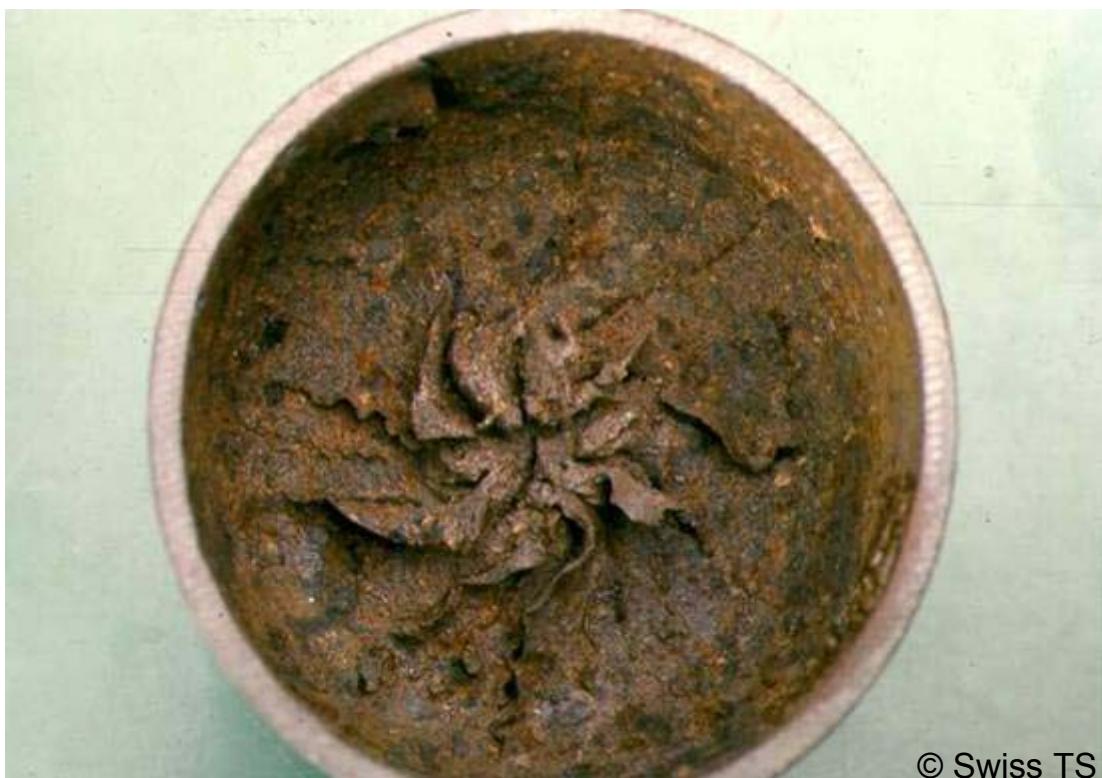
Picture 6: Manufacturer defect

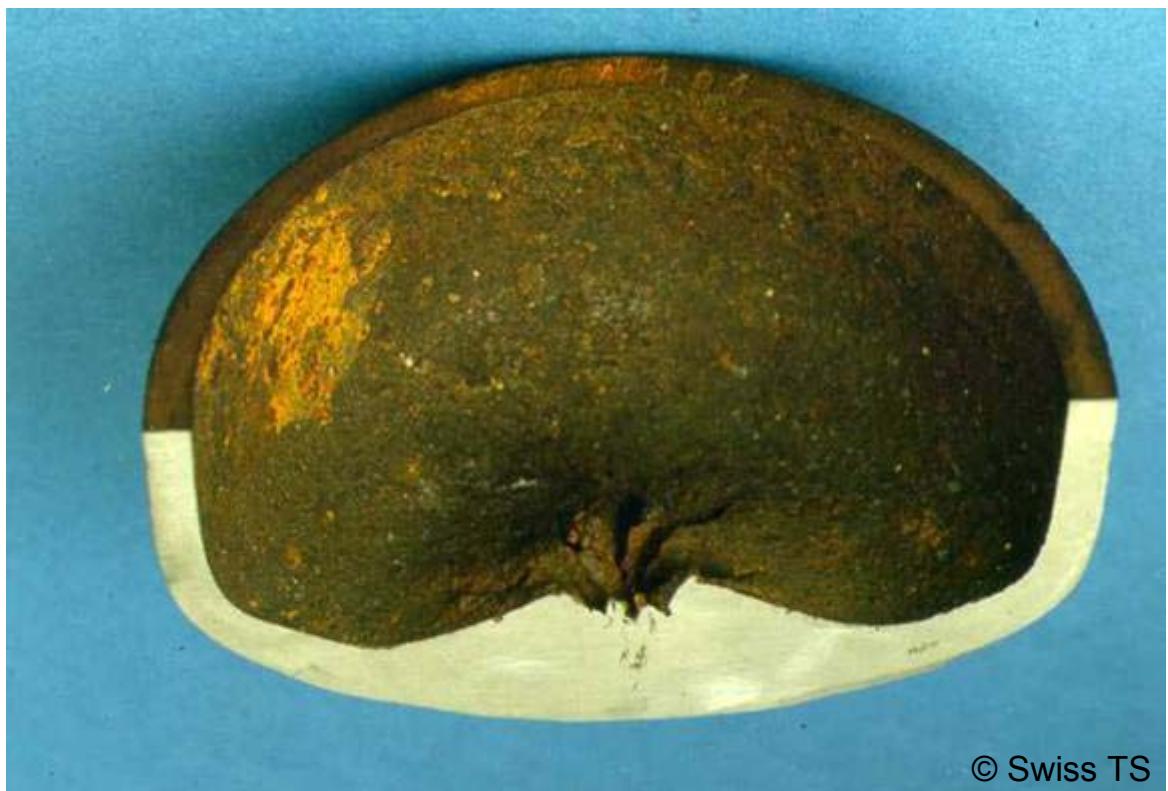
Abbildung 7: Manufacturer defect

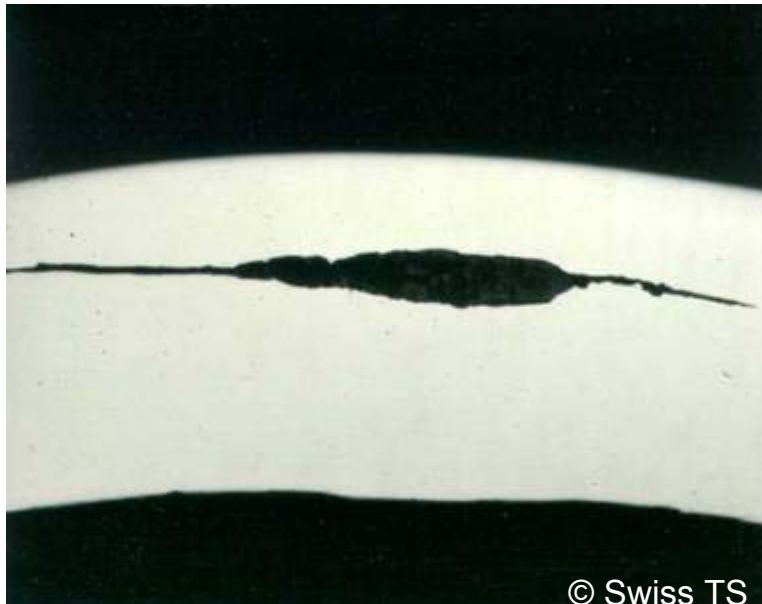
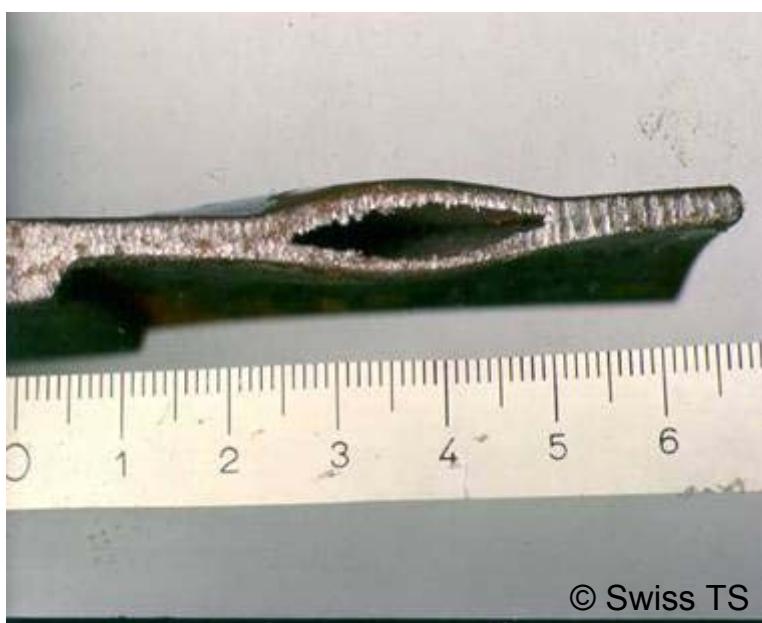
Picture 8 and 9: Lamination

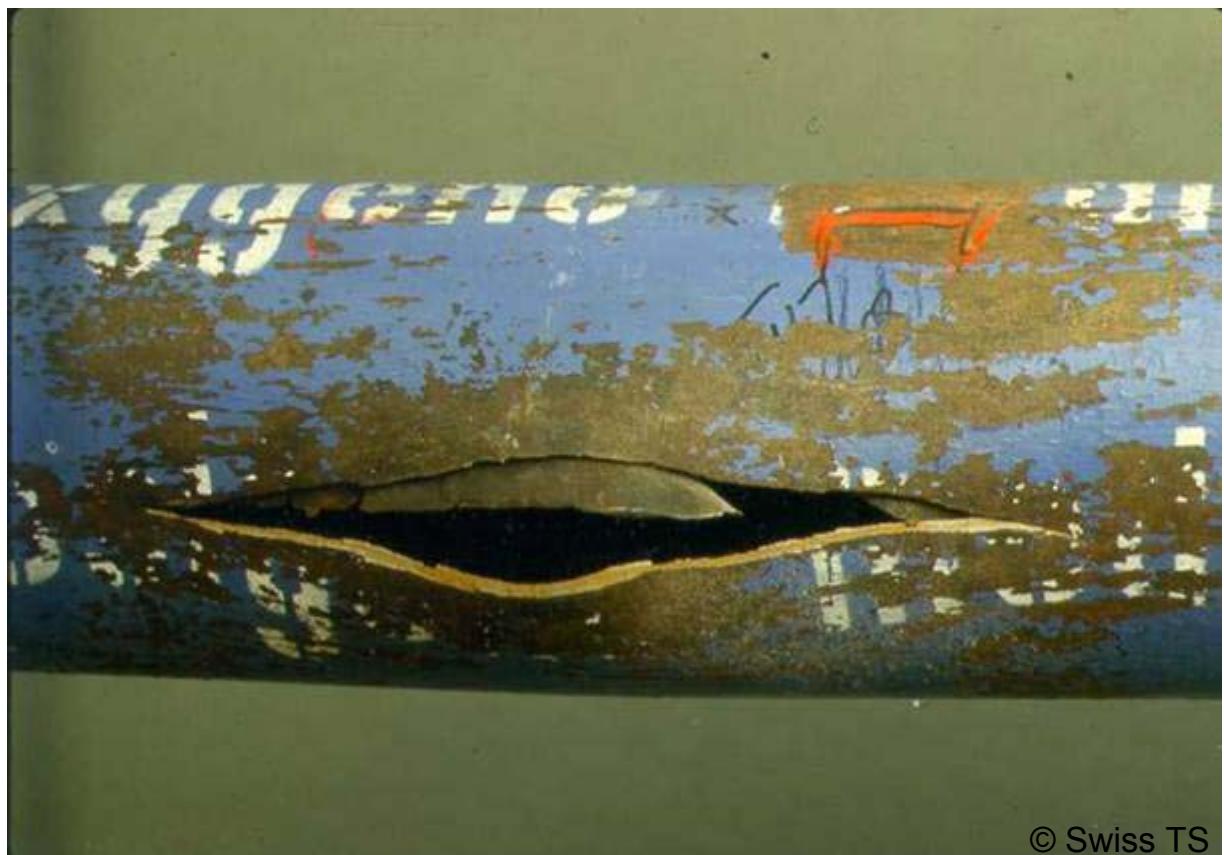
Picture 10: Lamination in the cylindrical part
Burst of the cylinder as a result of the flaw and
fatigue of material

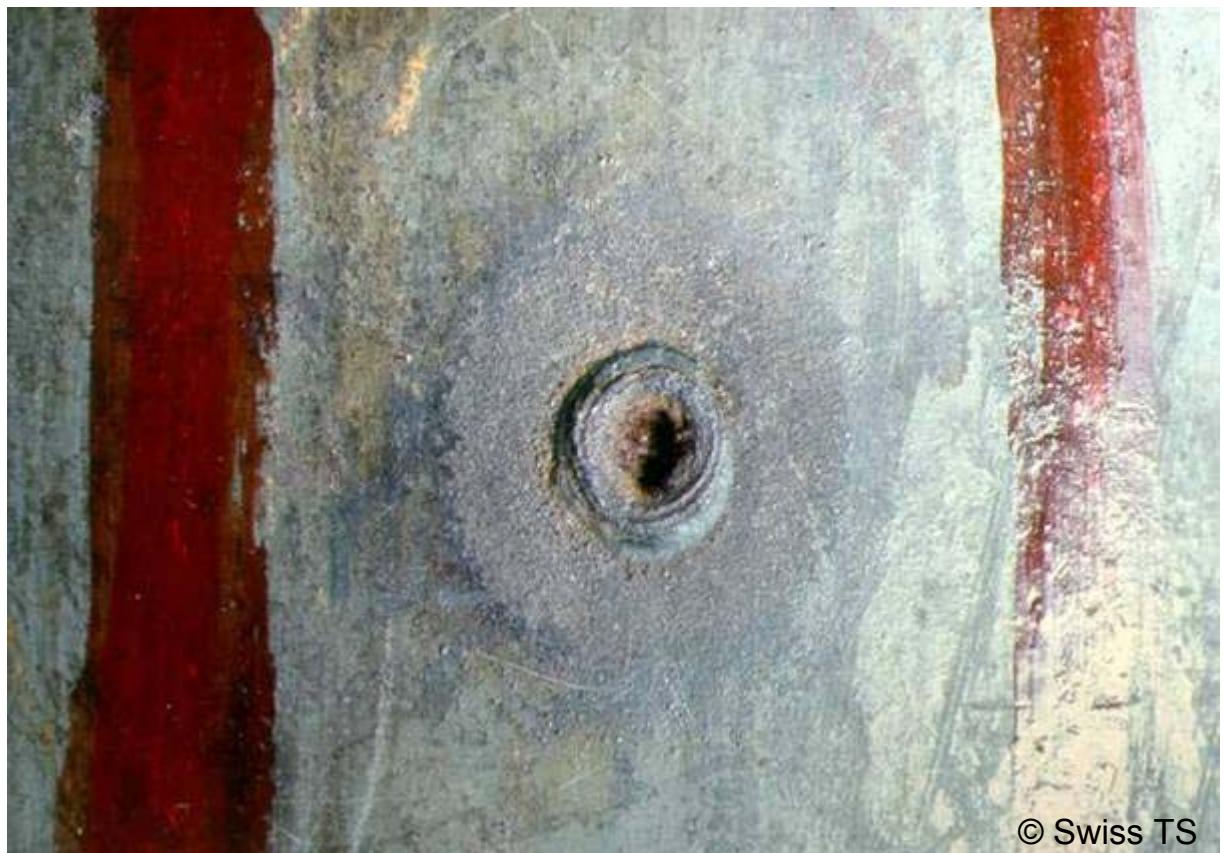
Picture 11: Welding spot

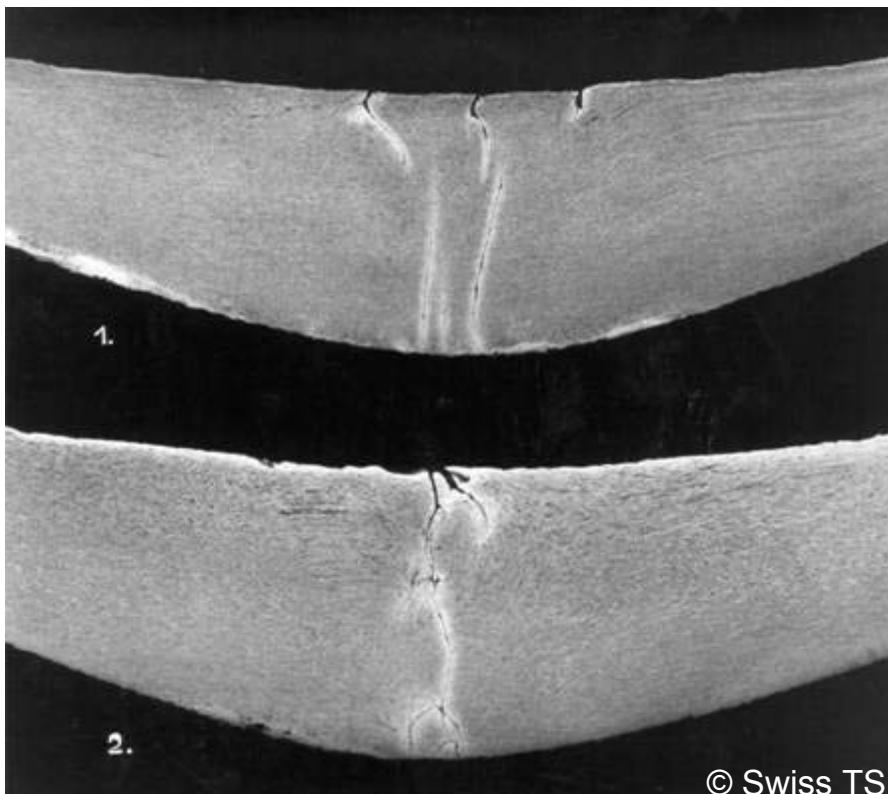
Picture 12 and 13: Inclusion in the base

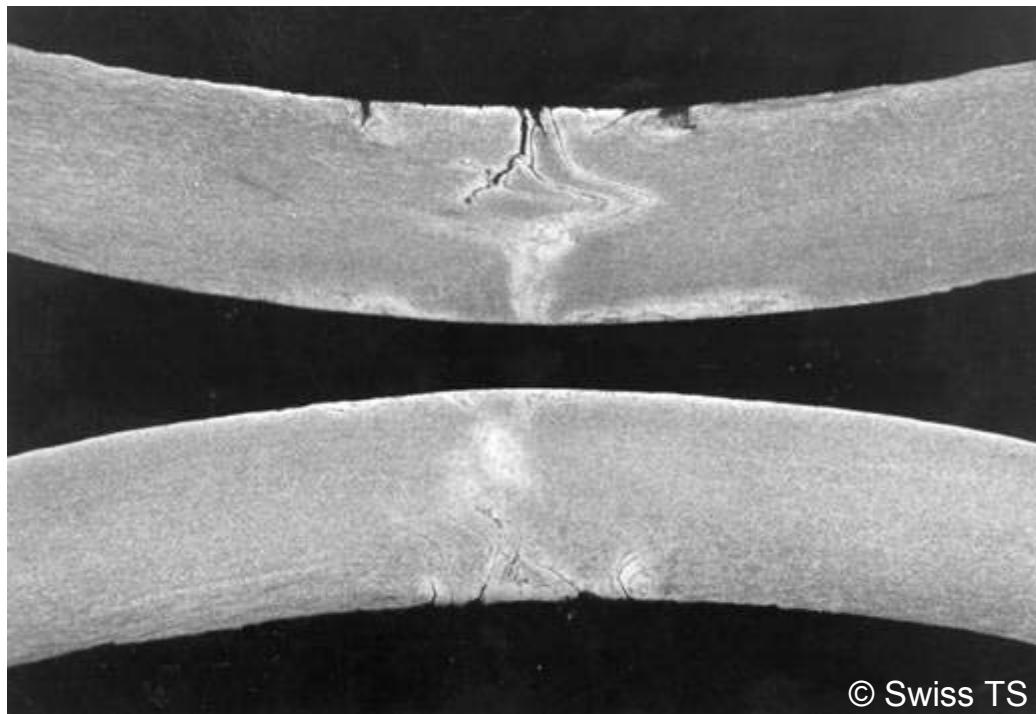
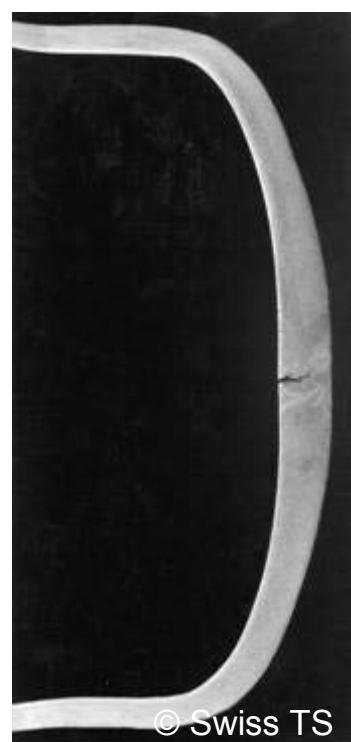
Picture 14 and 15: Inclusion in the base

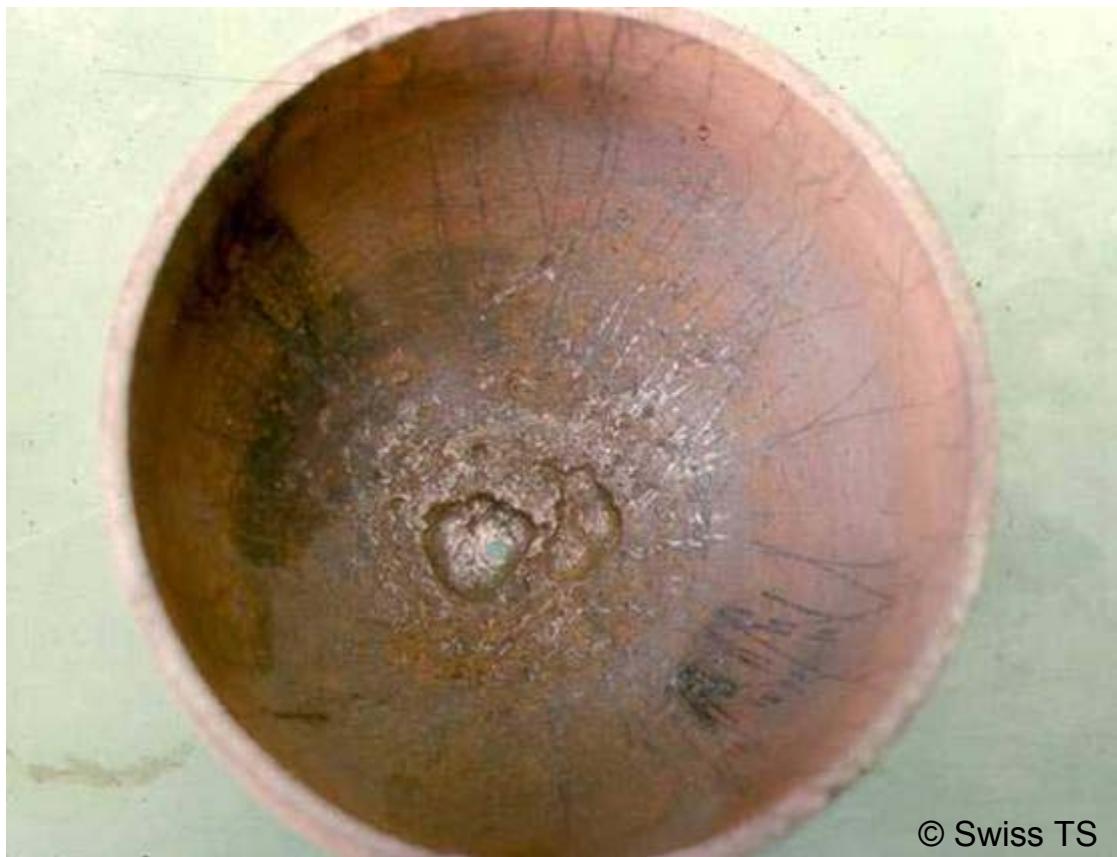
Picture 16: Pitting corrosion

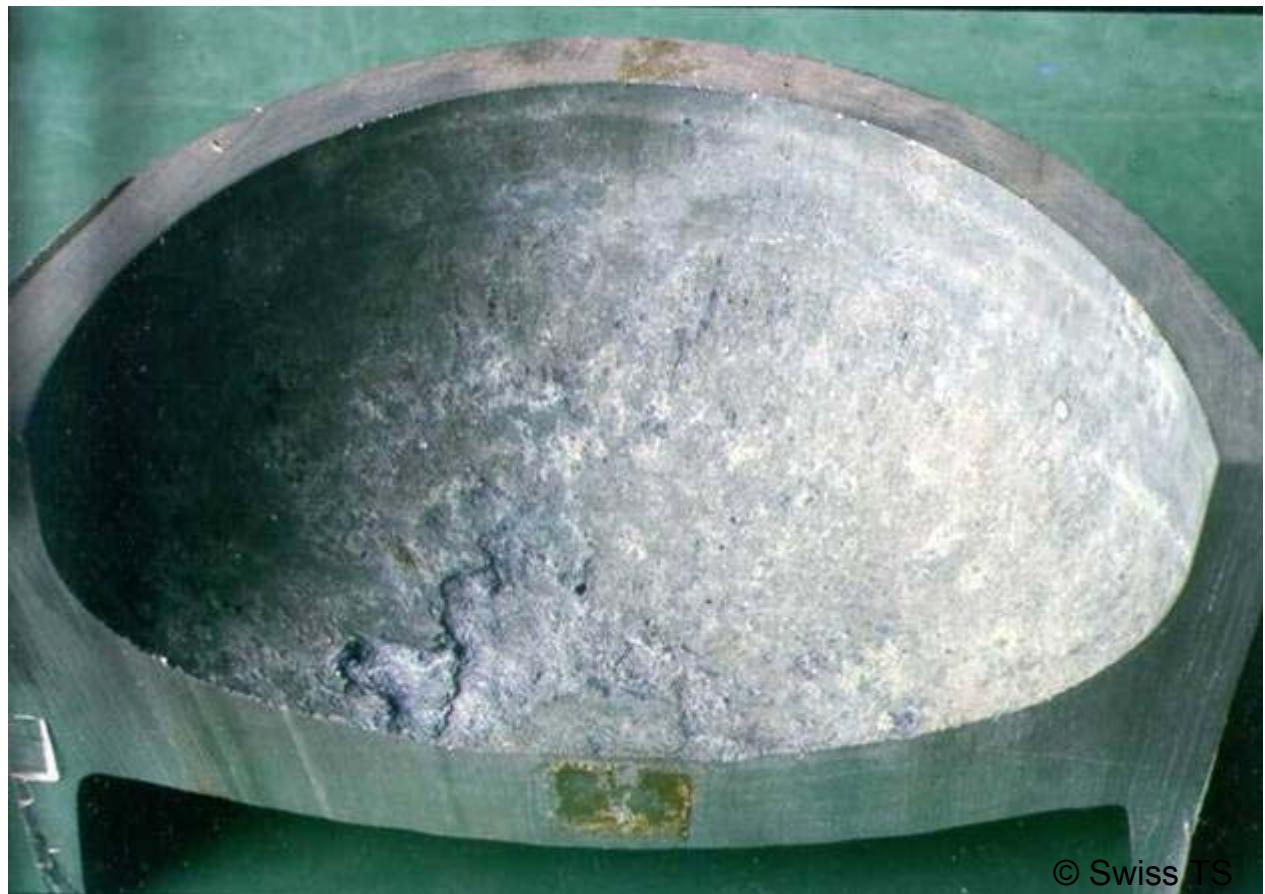
Picture 17: Corrosion of aluminium

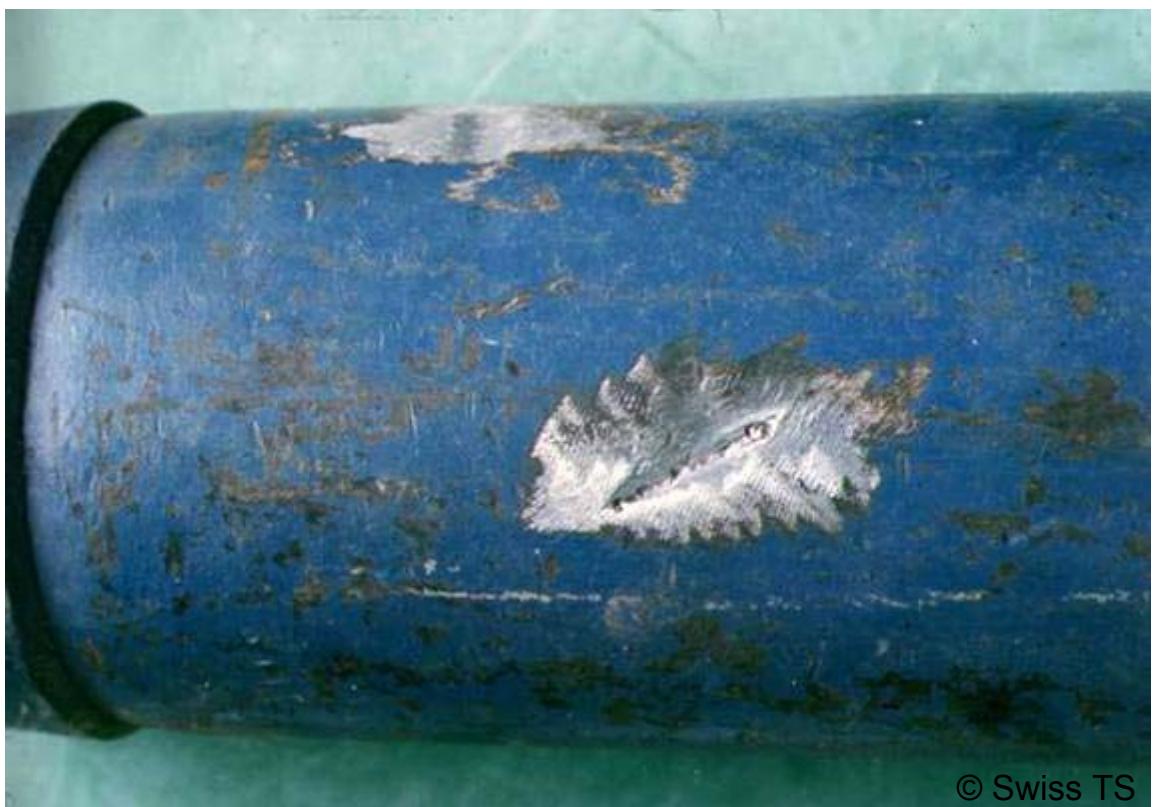
Picture 18: external mechanical damage

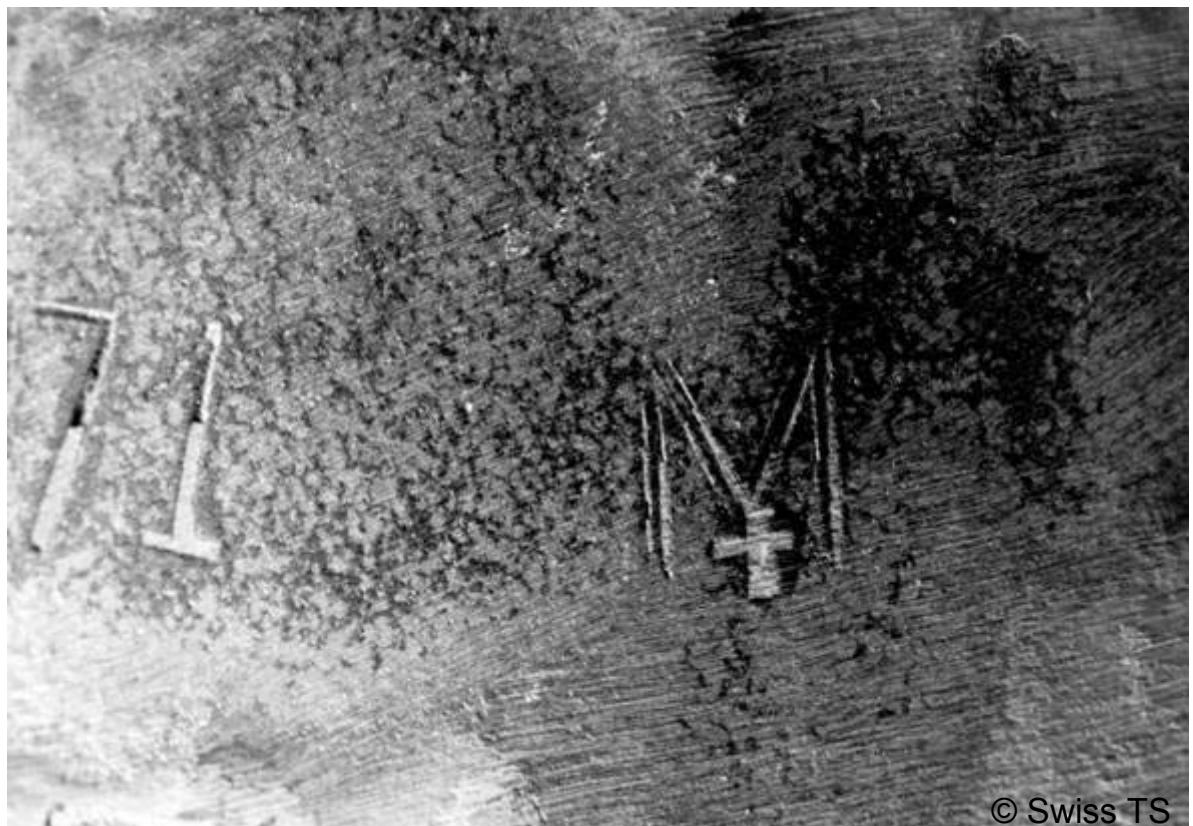
Picture 19: Self made control stamp

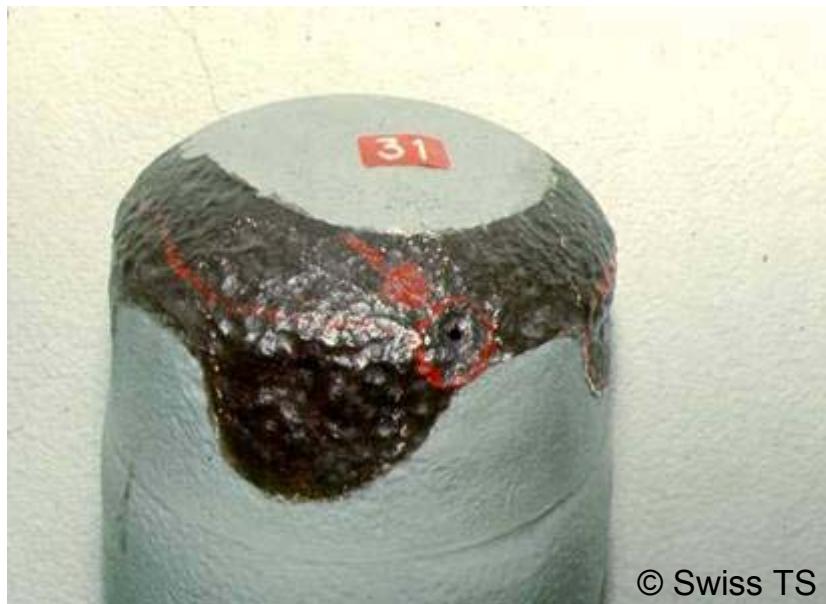
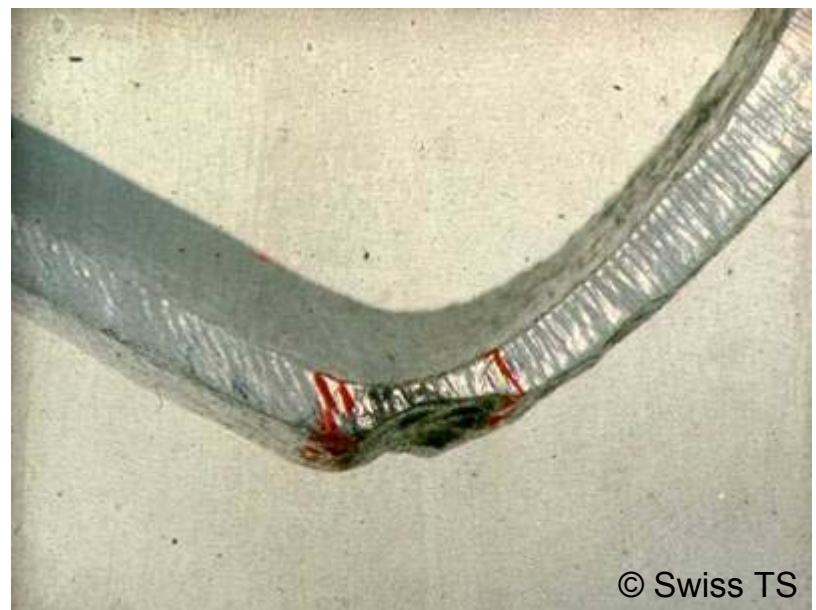
Picture 20 and 21: Corrosion below feet ring

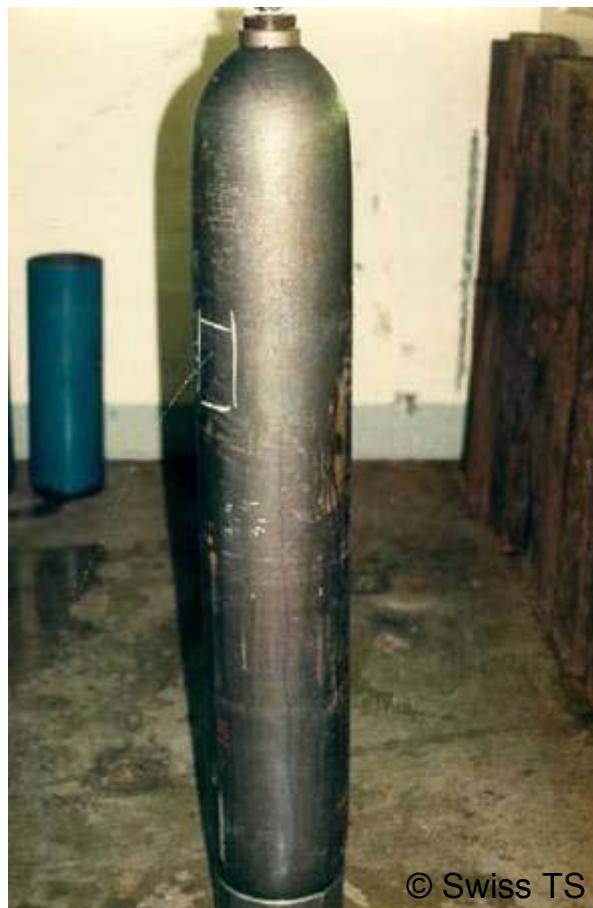
Leckage in the cylindrical part

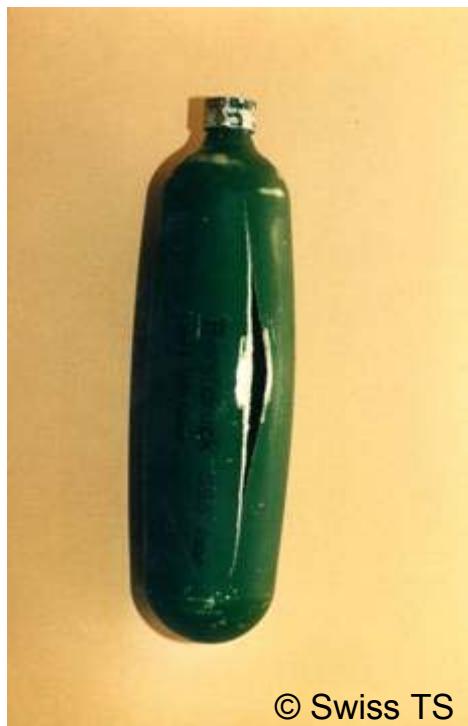
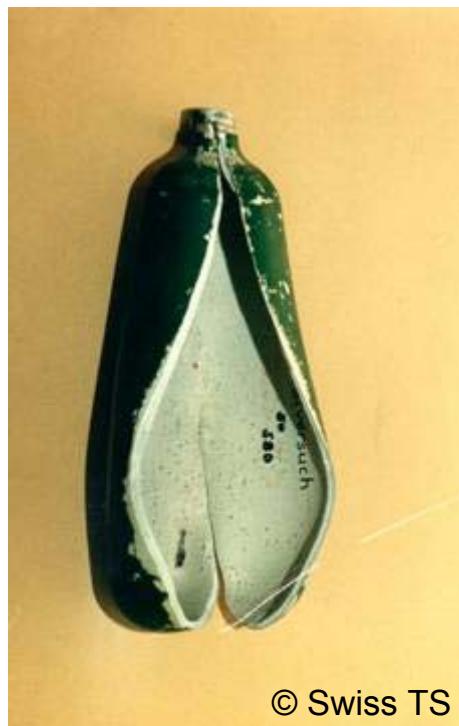
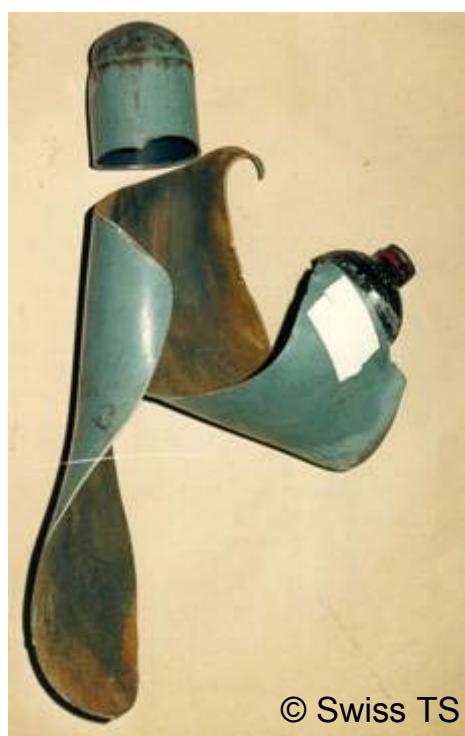
Picture 1 to 3: dislodged cylinder (1: water only, 2: water/air, 3: air only)

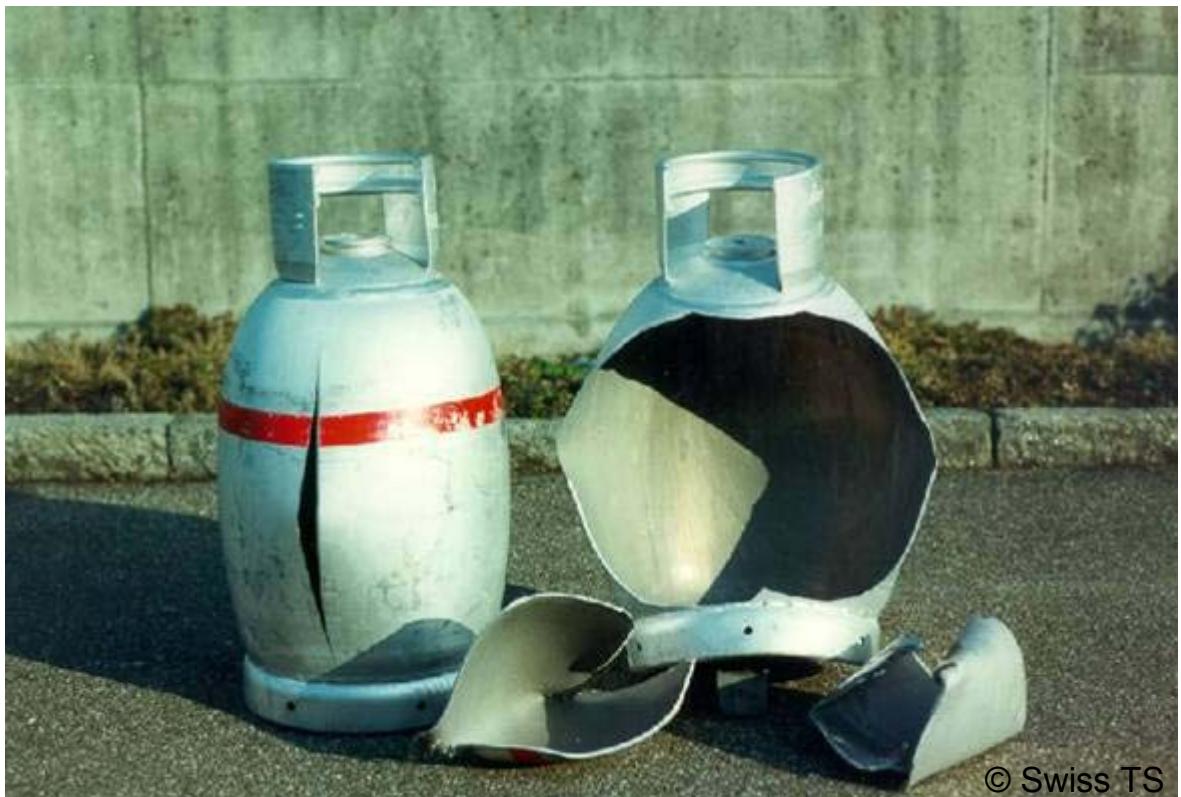
Picture 4: Comparison of water and air pressure burst test

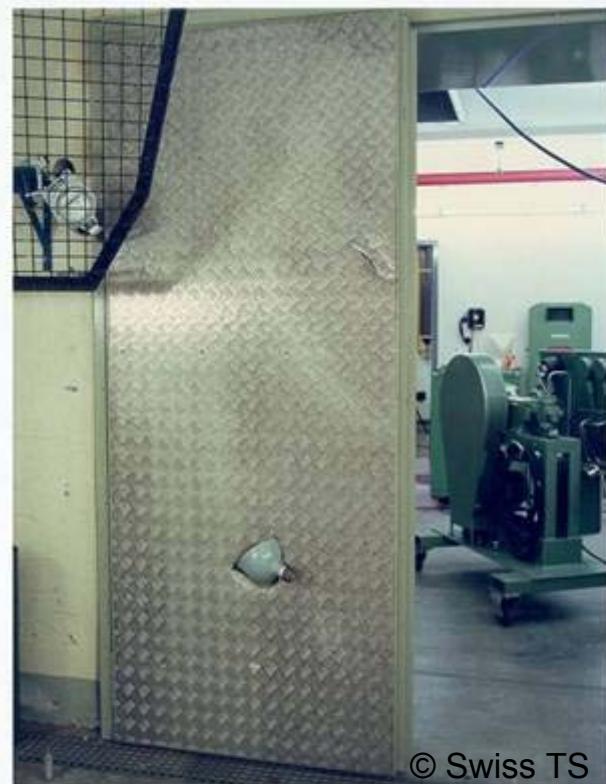
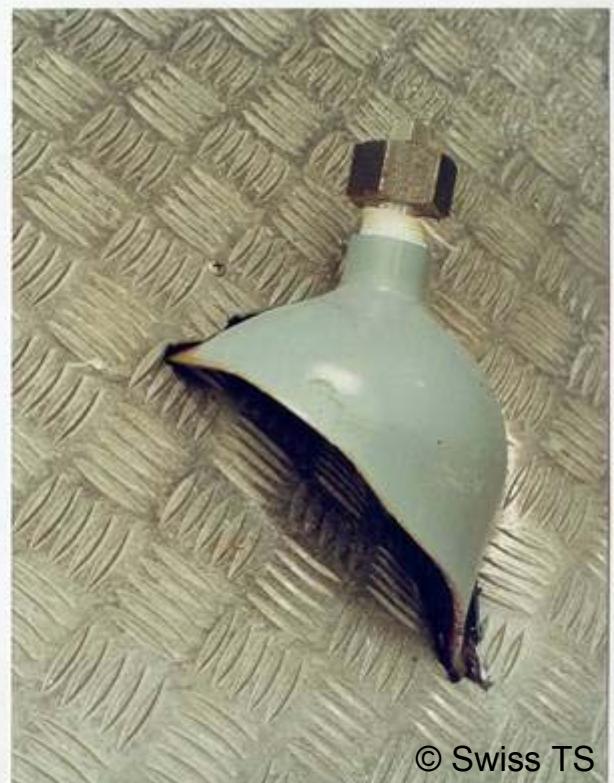
Picture 5 and 6: Result of a burst test
